FIGURE 2
SITE LAYOUT MAP
SERVICE OIL COMPANY, INC.
ELROY, WISCONSIN

TANK CLOSURE SITE ASSESSMENT RESULTS (METCO 4/6/93)

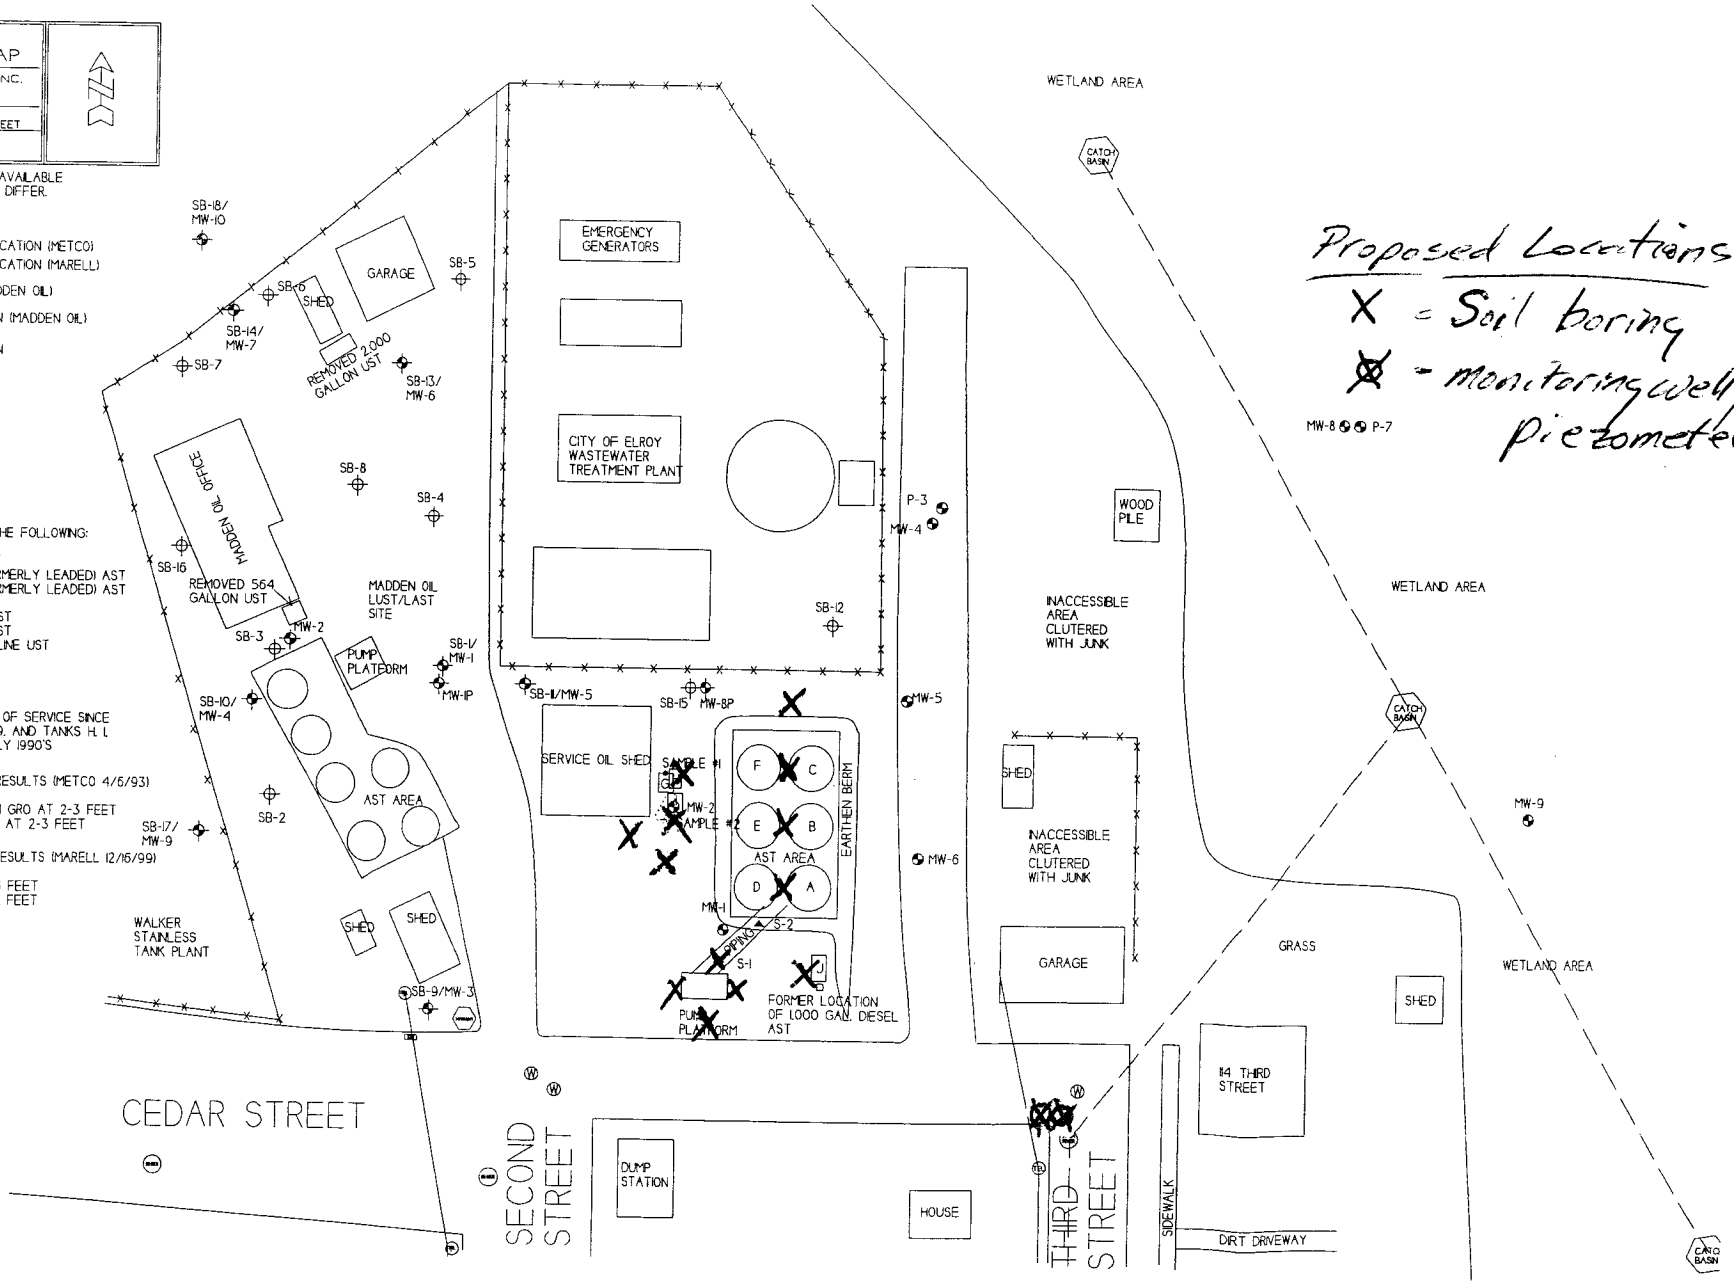
NOTE: TANKS A-F HAVE BEEN OUT OF SERVICE SINCE 2001. TANK G WAS REMOVED IN 1999, AND TANKS H, I, AND J WERE REMOVED IN THE EARLY 1990'S

S-1 - 18,000 PPM DRO AND 3,100 PPM GRO AT 2-3 FEET
S-2 - 25 PPM DRO AND 110 PPM GRO AT 2-3 FEET

SAMPLE #1 - 2,800 PPM GRO AT 5-6 FEET
SAMPLE #2 - 8,600 PPM GRO AT 1-2 FEET

Proposed Locations
X = Soil boring
⊗ = monitoring well/ piezometer.
